**Ingenieur- und Sachverständigenbüro  
für Fahrradtechnik**

## Expert's Report

- **As to the reconstruction of an accident as described**

| <b>Report number</b> | <b>16 / 8810-1</b> |

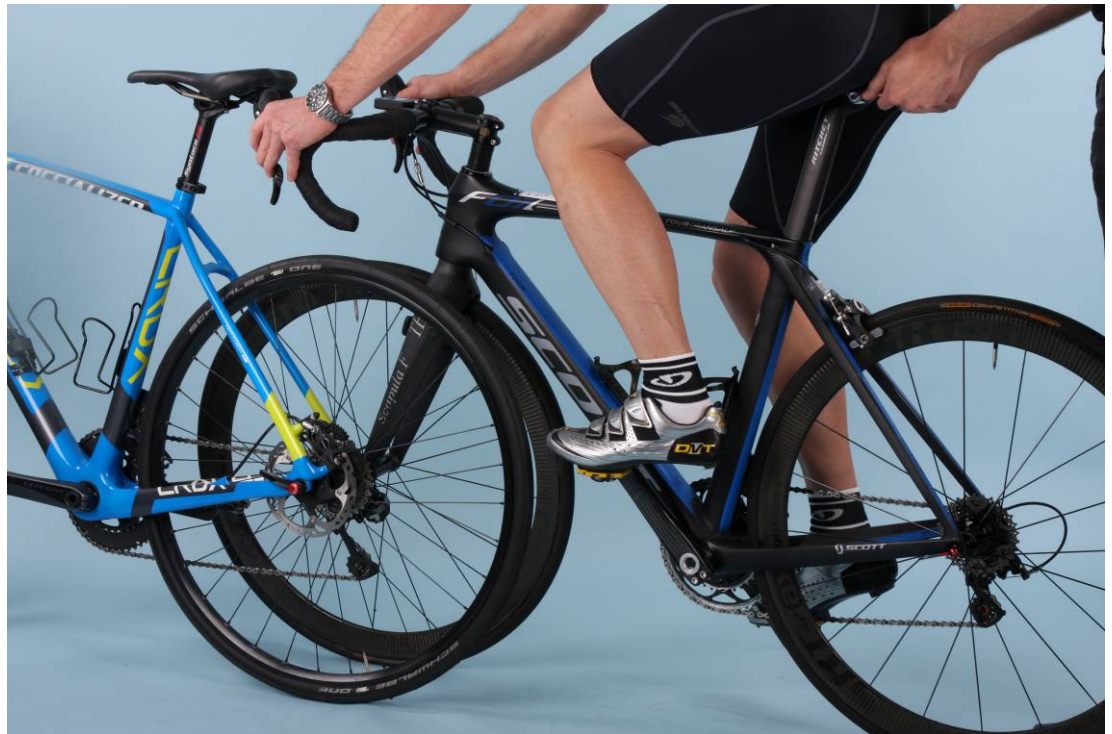
## Photos 1 + 2

Disc brakes are mounted to the left side of the bicycle. This also applies to road racing bicycles. If the details as to the remaining of the cyclist on the bicycle, i.e. the cyclist did not fall down, and as to the statement that the injury was caused by a brake disc, the left shin bone must have collided with the left side of a road racing bike riding in front of him (photo 1).

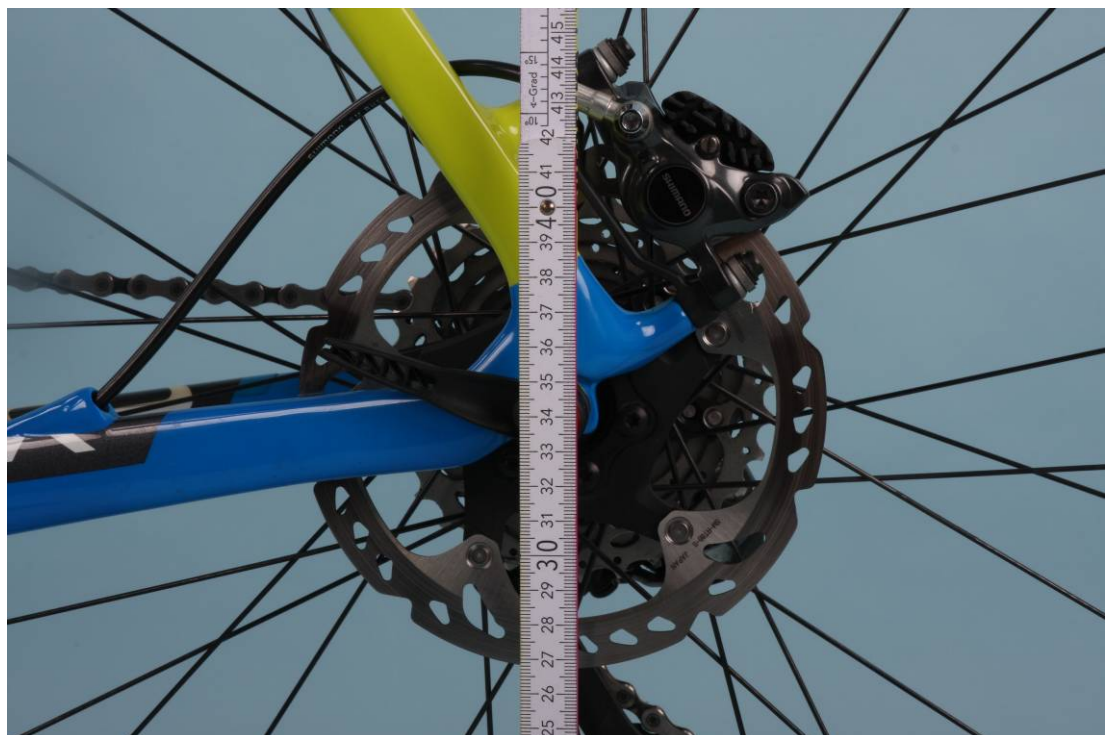
The centre of the rotational axis of the brake disc on a road racing bike is typically at a height of about 335 to 350 mm above ground. With a typical brake disc diameter of 160 mm the straight oriented brake disc is thus at a range of about 260 to 430 mm above ground during the ride (photo 2). As a matter of fact, the rear end of the brake disc is always at the height of the hub axle and thus at about 335 to 350 mm above ground (photo 3).

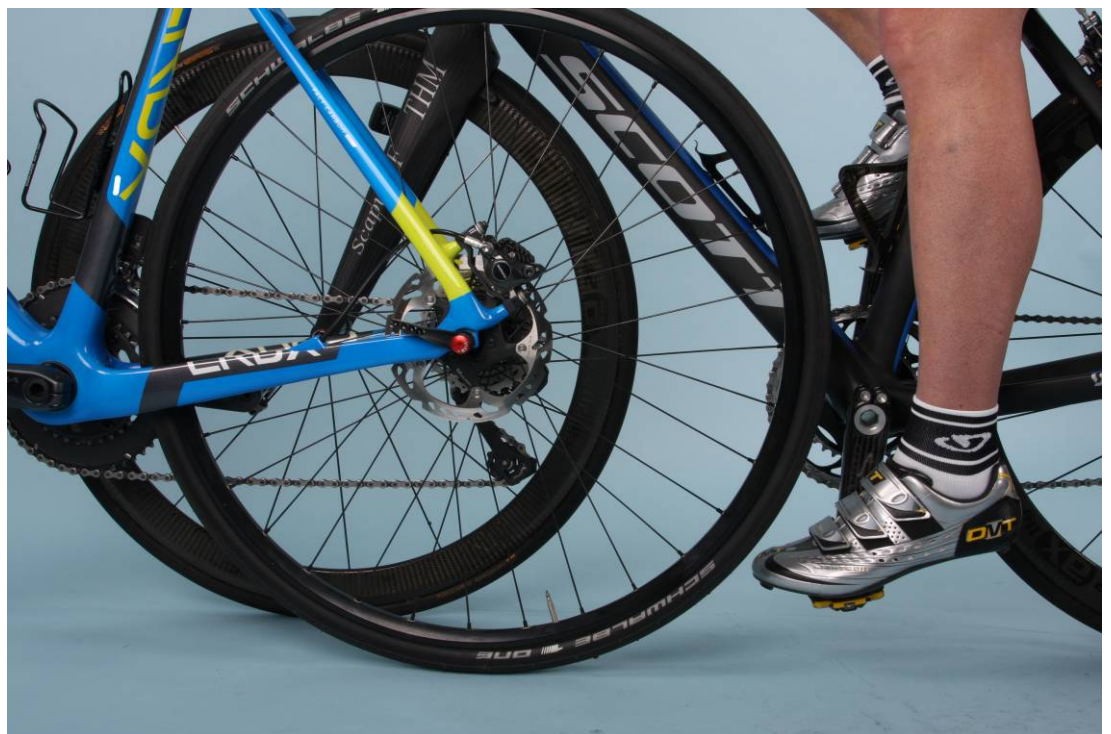
## Photos 5 + 6

If the colliding cyclist with the cleat engaged with the step-in pedal passes the bicycle in front of him by the right side, it will be impossible that the left leg and the engaged shoe collide with the brake disc mounted to the left side of the road racing bike cycling in front of him. Prior to that the handlebar of the bicycle bumping in from the rear collides with the saddle or the lower leg of the cyclist riding in front of him (photos 4 + 5). At the same time the front wheel collides with the rear derailleur and with the foot of the cyclist riding in front of him depending on the position of the foot. A collision of the foot of the cyclist bumping in from the rear with the rear tyre or in general with the rear wheel of the cyclist in front of him would be also very likely. This applies regardless of the crank arm's position along the circumference (photo 6).

In the case of this scenario, a fall of the bumping in cyclist would be nearly the imperative consequence due to the lateral force application into the area of the handlebar. This also applies in particular, as the front wheel would get stuck at the rear derailleur, thus resulting into a fall.

**Finding:** If the colliding cyclist passes the bicycle of the cyclist riding in front of him on the right side with his shoe engaged with the step-in pedal system, a contact between the left lower leg and the brake disc will be impossible.

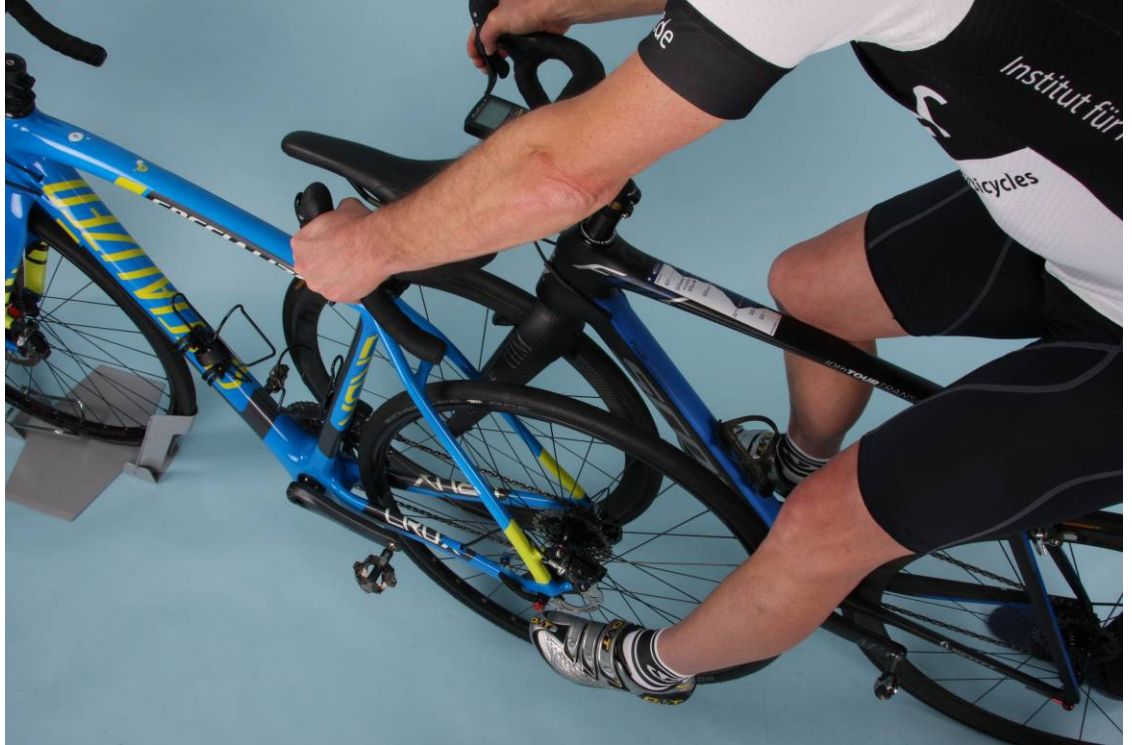
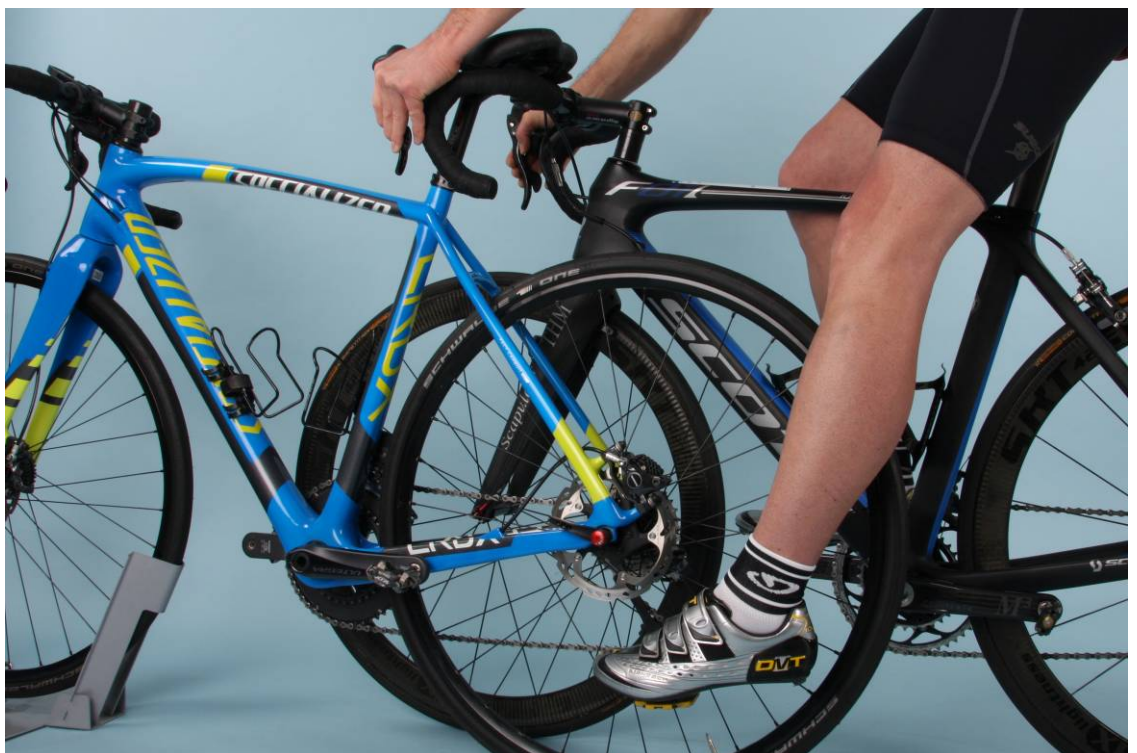
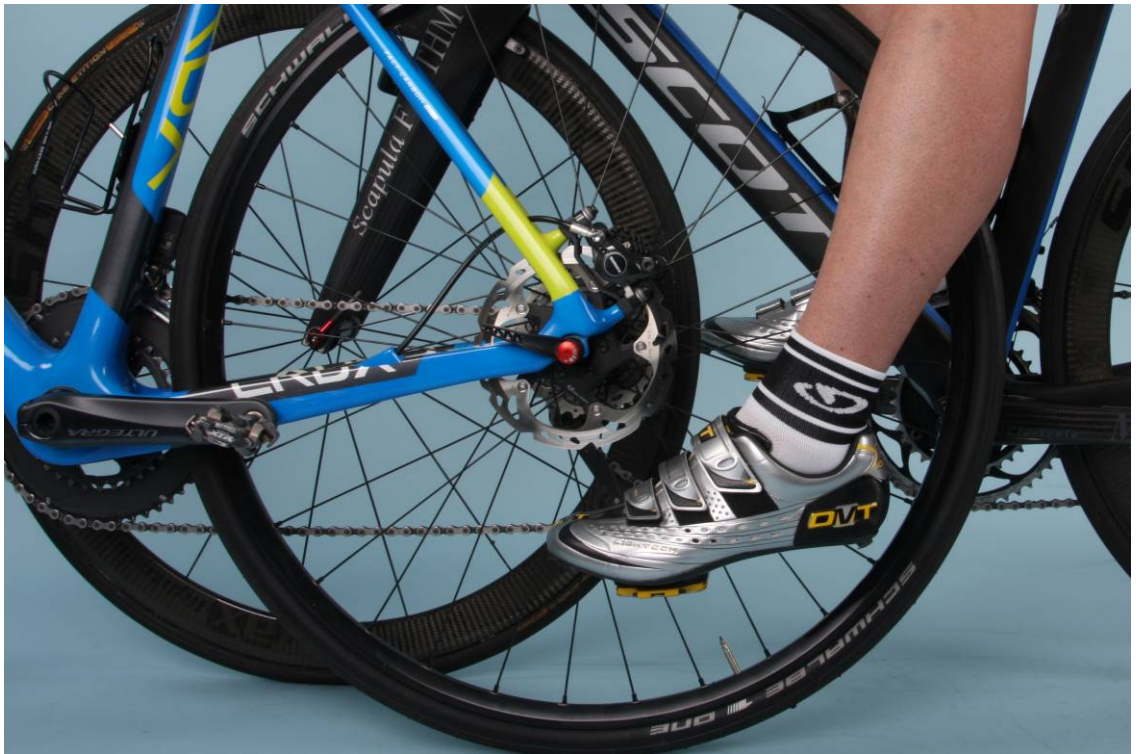
The reconstruction with a cyclist of identical, bodily dimensions shows this very clearly. Prior to a contact of the shin bone with the brake disc of the cyclist riding in front, the handlebar of the colliding bicycle will collide with the saddle and/or lower leg of the cyclist riding in front of him. In addition, the collision of the front wheel with the rear derailleur would be nearly imperatively the consequence. Furthermore, in the case of a cyclist seated in the saddle it is impossible in terms of anatomy that the brake disc gets in contact with the respective area on the shin bone. The distance is much too great (photos 7 - 9).

In the case of this scenario, a fall of the bumping in cyclist would also be the nearly imperative consequence due to the lateral force application into the steering area and the collision between rear derailleur and front wheel.

**Finding:** If the colliding cyclist passes the bicycle riding in front of him on the right side with the shoe disengaged from the pedal system, a contact between the documented injury on the left lower leg and the brake disc of the road bike riding in front of him is not possible either.

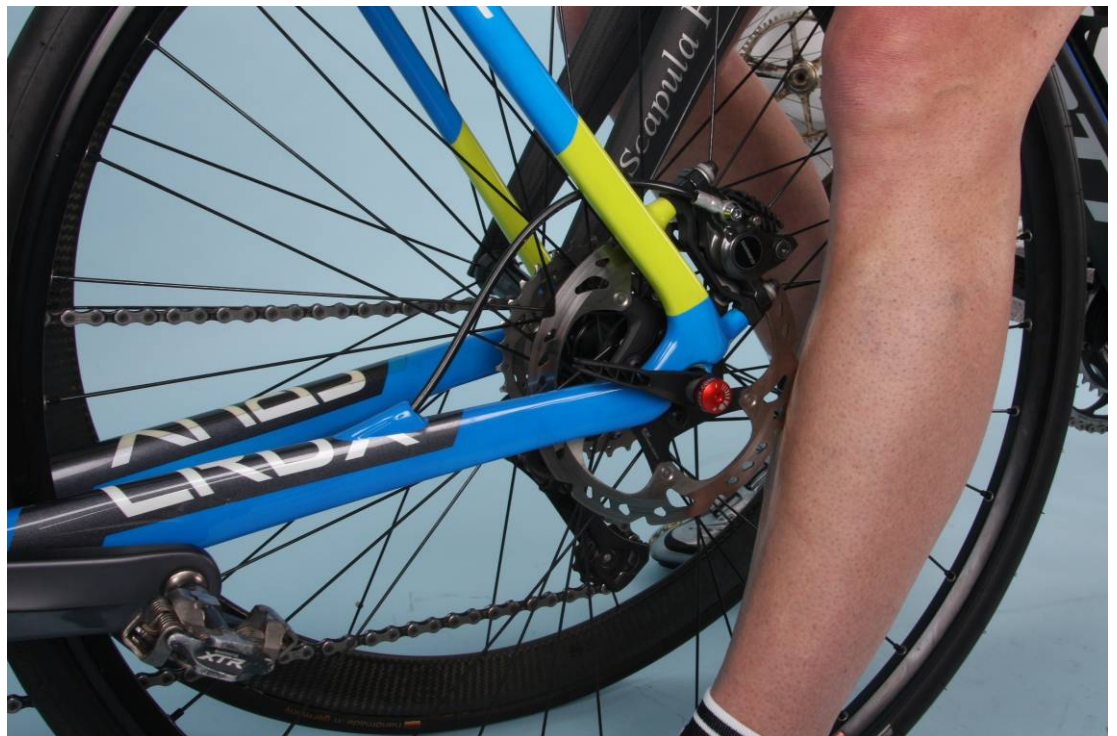
Photos 11 + 12

It is conceivable that the rear cyclist bumps straight into the road racing bike with disc brakes in front of him with the shoe disengaged from the pedal system. If the cyclist riding at the back passes the bicycle in front of him on the right side while seated on the top tube with the cleat disengaged from the pedal, it is impossible due to the geometry of a road racing bike, in particular due to the gap between the brake disc and the spokes of the rear wheel, that the injured area on the left leg of the colliding cyclist gets in contact with the brake disc of the road racing bike in front (photos 10 + 11). The reconstruction showed very clearly that this could have led, if at all, to an injury on the inner side of the lower leg (photo 12). This applies even in case of the cyclist sliding right to the fork steerer tube on the top tube.

But before this could happen the handlebar of the colliding bicycle ought to collide with the saddle and/or the lower leg of the cyclist in front of him.

In the case of this scenario, a fall of the bumping in cyclist would also be the nearly imperative consequence due to the lateral force application into the steering area and the collision between the front wheel and the rear derailleur.

**Finding:** If the colliding cyclist passes with the shoe disengaged from the pedal system on the right side of the bicycle riding in front, a contact between the documented injury on the left lower leg and the brake disc of the road bike in front of him will nevertheless not be possible either.

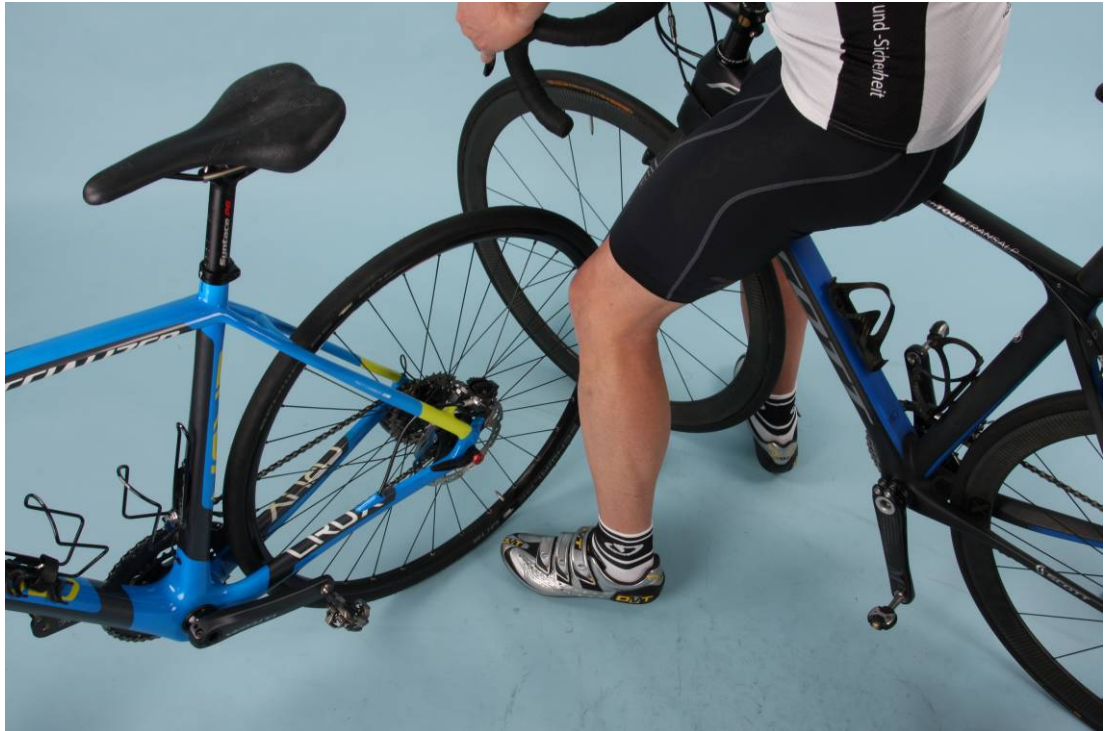
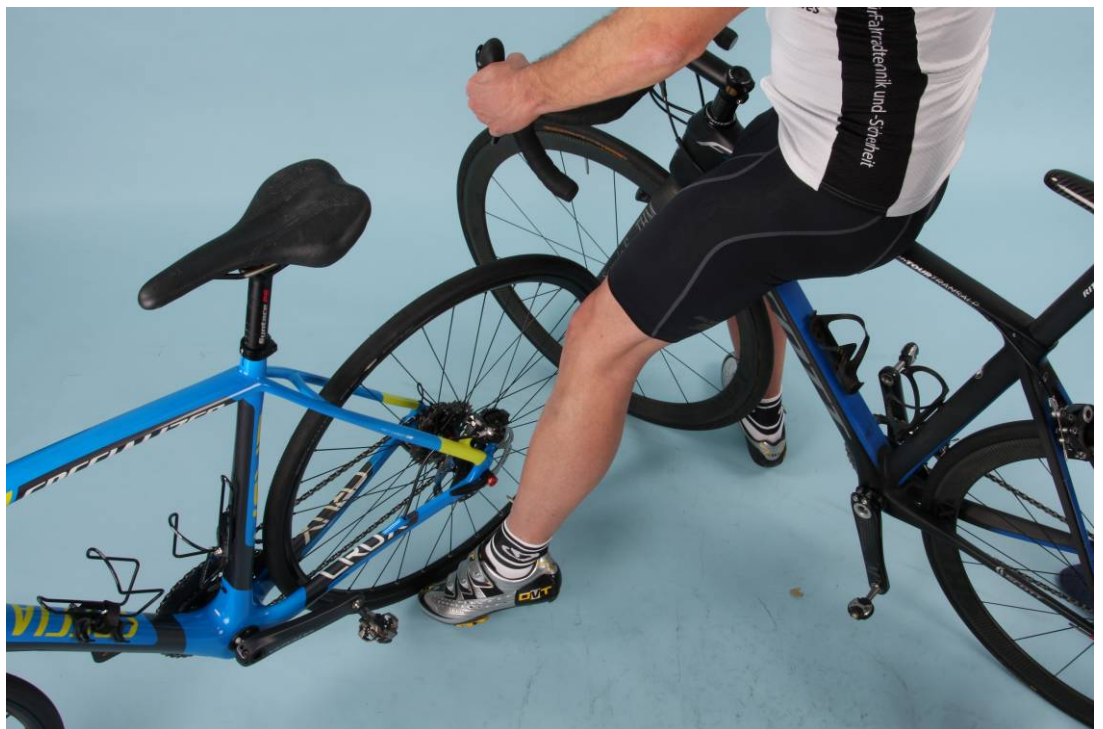
Photos 13 + 14

It is also conceivable that the rear cyclist with the shoe disengaged from the pedal system bumps straight into the road racing bike with disc brakes standing crosswise in front of him. However, due to the geometric dimensions, i.e. the distance between disc brake and spokes of the rear wheel, and in consideration of the human anatomy, it is impossible in this case, as well, that the injured area on the left leg of the colliding cyclist gets in contact with the disc brake of the road racing bike in front without a fall as a consequence (photos 13 + 14).

**Finding:** If the colliding cyclist, with the shoe disengaged from the pedal system, bumps into the bicycle standing crosswise in front of him, a contact between the documented injury on the left lower leg and the brake disc of the road racer cycling in front of him is nevertheless not possible without resulting in a fall.

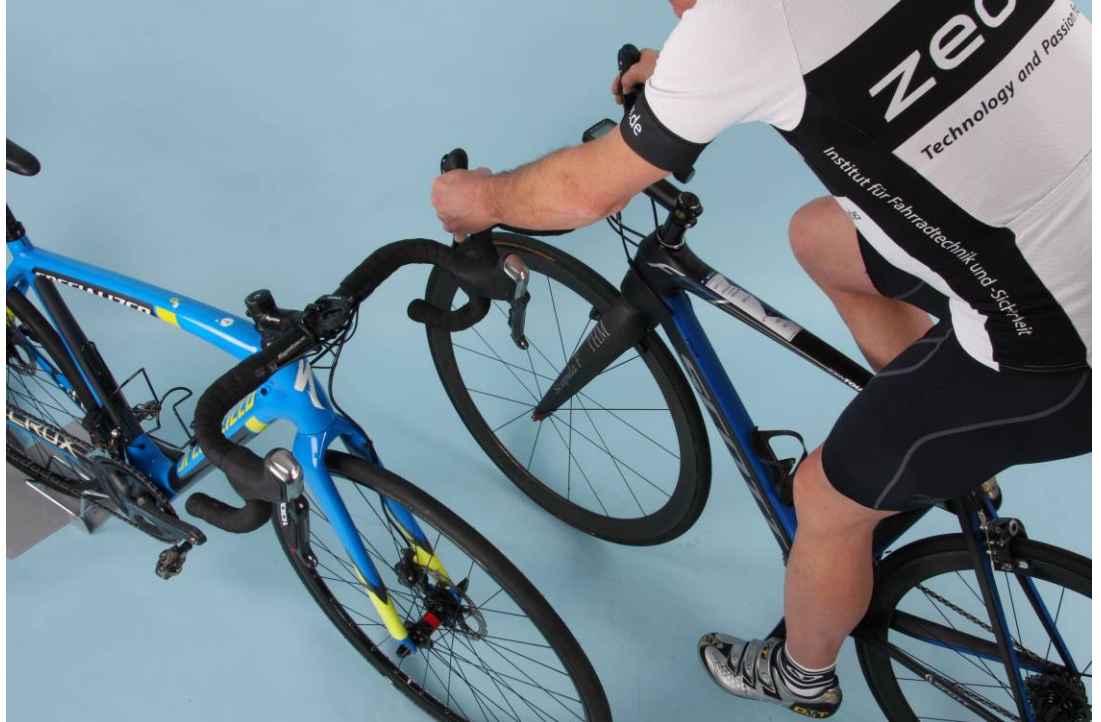
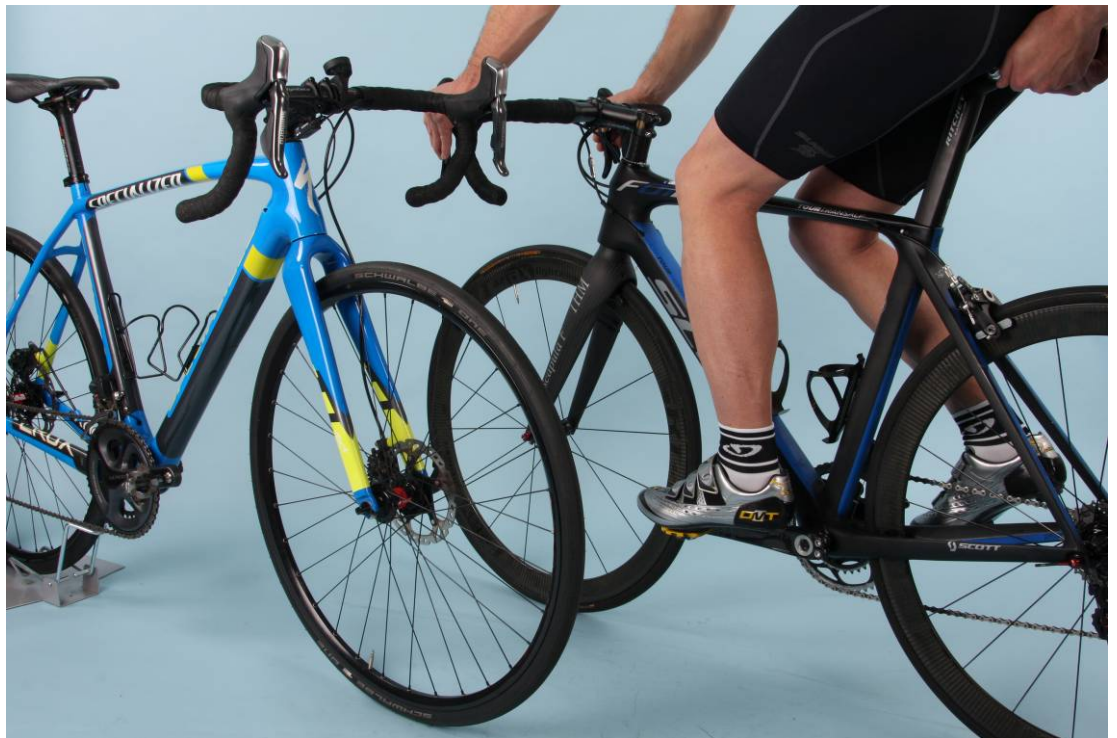
Photos 15 + 16

It is also conceivable that due to the course of accident as described, the cyclist riding in front turns by 180 degrees, thus standing shortly in the opposite direction of motion. A contact of the shin bone with the brake disc would require both handlebars and/or brake/shifter units to interlock (photos 15 + 16).

A fall of the colliding cyclist would be the imperative consequence, also due to the speed and ground, as documented.

**Finding:** If the colliding cyclist bumps into the bicycle in front which has turned by 180 degrees, a contact with the location of the documented injury on the left lower leg will not be impossible.

This would in addition result in a fall of the colliding cyclist due to the unavoidable interlocking in the area of both handlebars.
