**Ingenieur- und Sachverständigenbüro  
für Fahrradtechnik**

## Expert's Report

- **As to the reconstruction of an accident as described**

| <b>Report number</b> | <b>16 / 8810-1</b> |

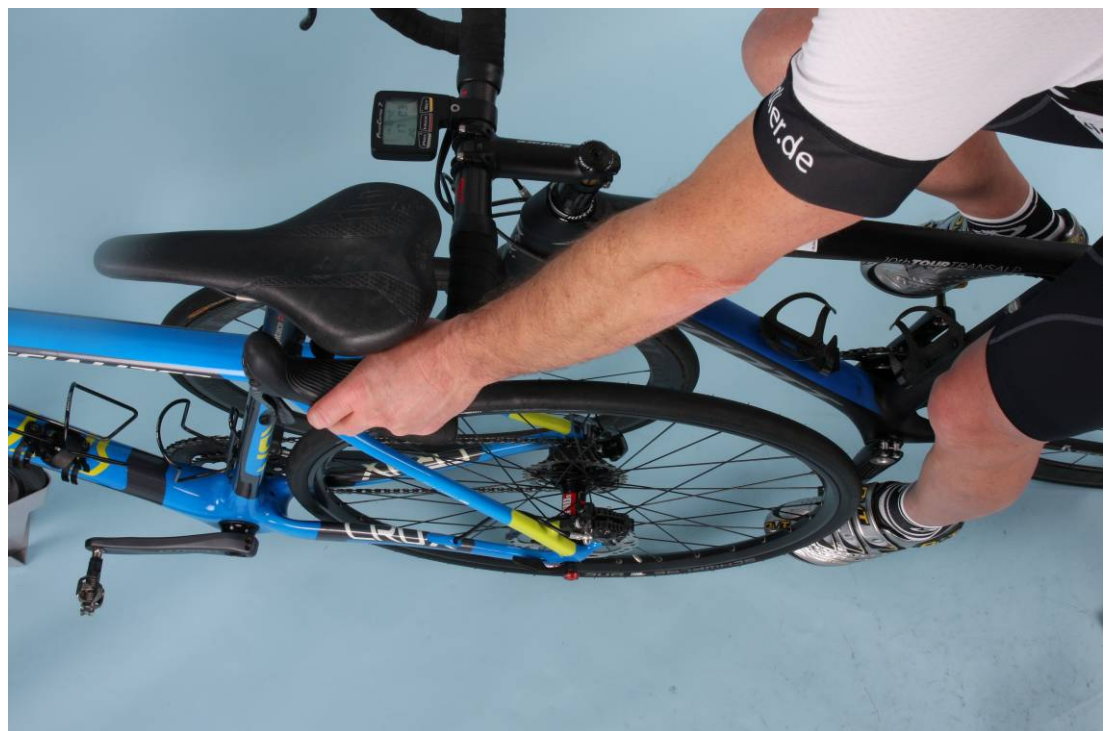
### Photos 3 + 4

The centre of the rotational axis of the brake disc on a road racing bike is typically at a height of about 335 to 350 mm above ground. With a typical brake disc diameter of 160 mm the straight oriented brake disc is thus at a range of about 260 to 430 mm above ground during the ride (photo 2). As a matter of fact, the rear end of the brake disc is always at the height of the hub axle and thus at about 335 to 350 mm above ground (photo 3).
